427 Northbound Road Repair

427 Northbound Road Repair Using TBX2500 Biaxial Geogrid

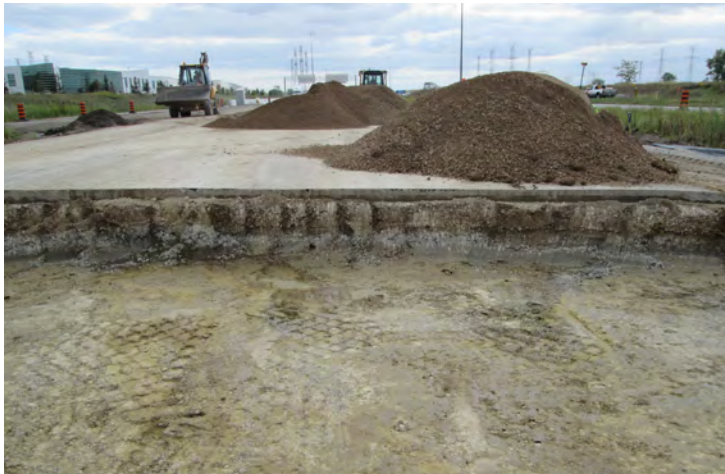
Saturated subgrade and damaged asphalt removed

Badly Saturated subgrade due to silt-laden drainage ditches caused cracking and deflection to the paved surface of the northbound lanes of Highway 427, south of the Highway 7 overpass. A cost effective and timely solution was required to repair this major arterial route through Toronto.

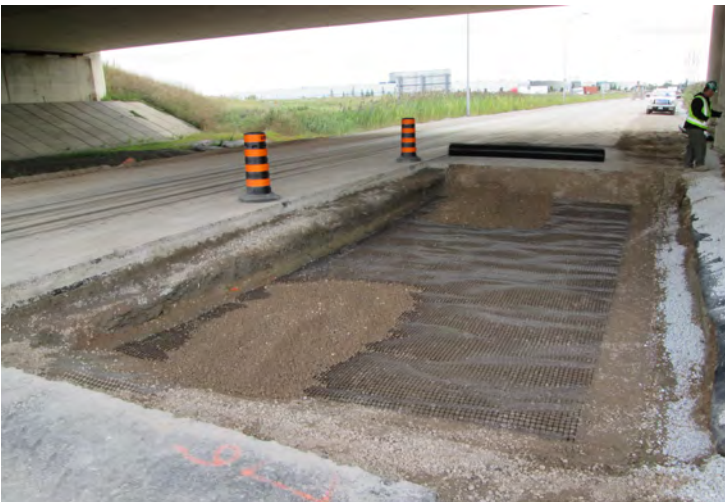
TBX2500 laid out over excavated grade

The use of TBX2500 allowed the contractor to add a minimum of 250mm of equivalent aggregate depth to their existing excavation depths without the cost and time of additional excavation cost or aggregate volume. The this major thoroughfare was quickly repaired and repaved to minimize the resulting congestion, whilst maximizing the maintenance cycle expected for this type of repair.

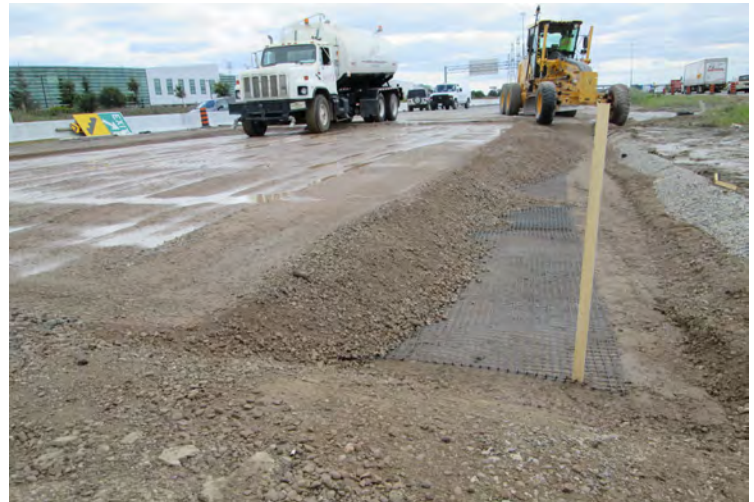
Structural fill laid and compacted on TBX2500
