# Dam Rehabilitation Millbrook, ON

## CASE STUDY

Product Installed: Flexamat

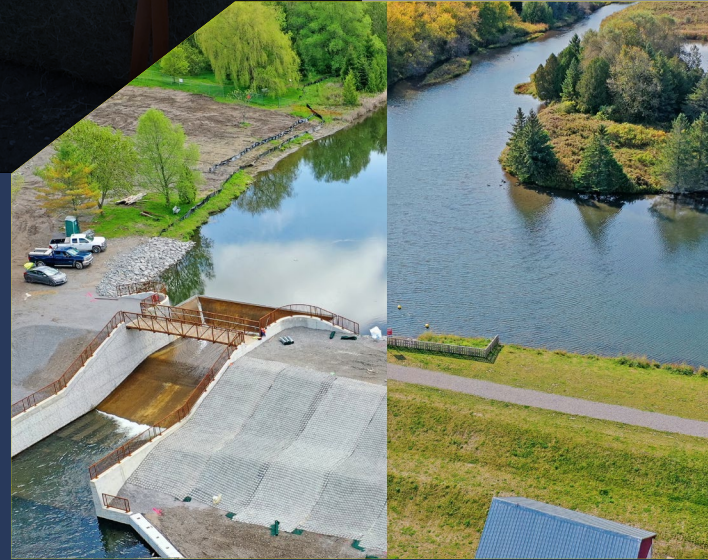
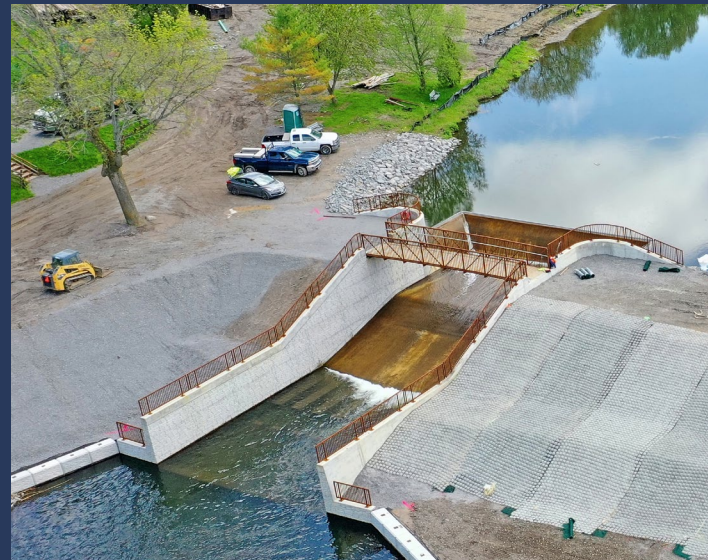
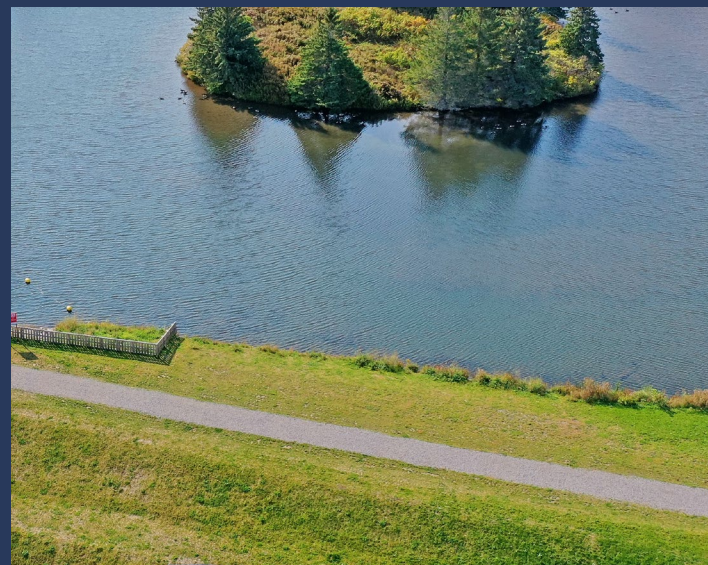
Once the spillway was regraded, the contractor installed Flexamat. The system consists of concrete blocks tied together with high strength geogrid, creating a flexible, highstrength hard armour against erosion. The mat allows vegetation to establish while serving as a hard armour erosion control solution.

Rolls were installed side by side down both sides of the dam. FM200 (turf reinforcement mat) was installed along the longitudinal seams for added protection. Seams were then secured every 2' using 18" u-shaped rebars. Once the entire dam was lined with Flexamat, a cover soil followed by hydroseeding was applied followed by a layer of C200 (double coconut blanket). Vegetation was established later in the summer complementing the surrounding park.
