# Brant — Storm Sewer Outlet Protection

## CASE STUDY

Year of Construction: 2023

Location: Brant, ON

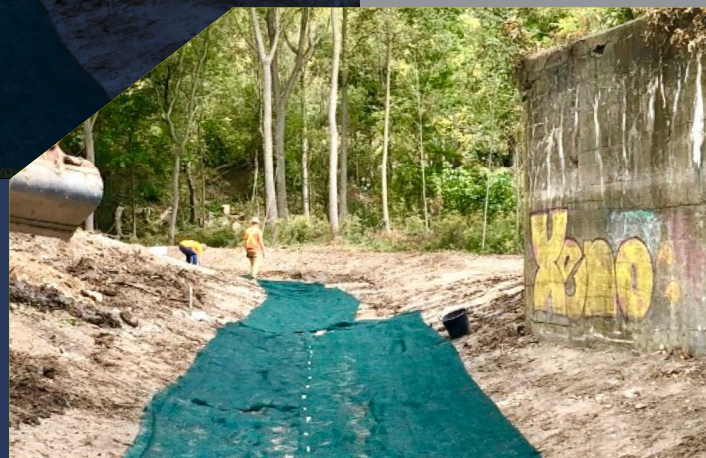
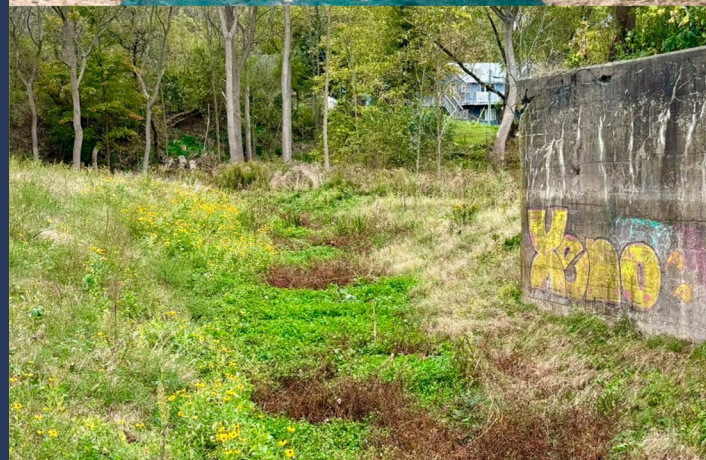
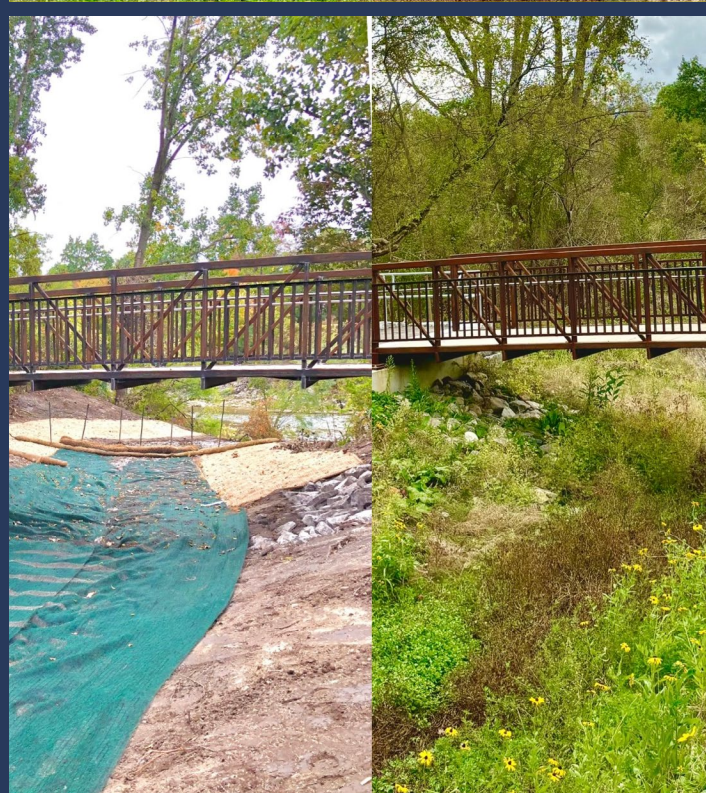
The rehabilitation process began with the regrading of the channel, reshaping it to promote effective water flow and reduce future erosion risks. A seed mix was applied to encourage natural vegetation growth. For additional reinforcement, a double net coconut blanket (C200B), a biodegradable material, provided temporary erosion control while allowing plants to establish. C200B has a design performance ratings of 2.7m/s of velocity and 108Pa of shear stress under unvegetated conditions.

The bottom of the channel was lined with FM200, a turf reinforcement mat made from polypropylene fibres, offering long-term durability and strength. FM200 has design performance ratings of 6.65m/s of velocity and 158.4Pa of shear stress under unvegetated conditions.

Within months, vegetation flourished, filling the open voids in the blankets, creating a fully vegetated, stabilized channel that seamlessly blended into the park's natural landscape.
