# Blue Mountains, ON Interceptor Swale Reinforcement

Product Installed: Flexamat

System: Erosion Control

CASE STUDY

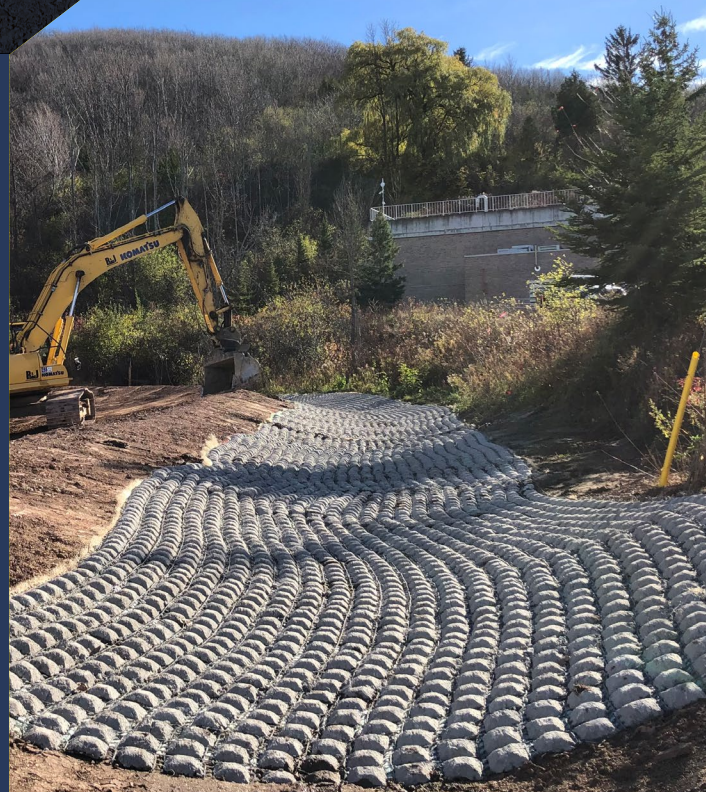
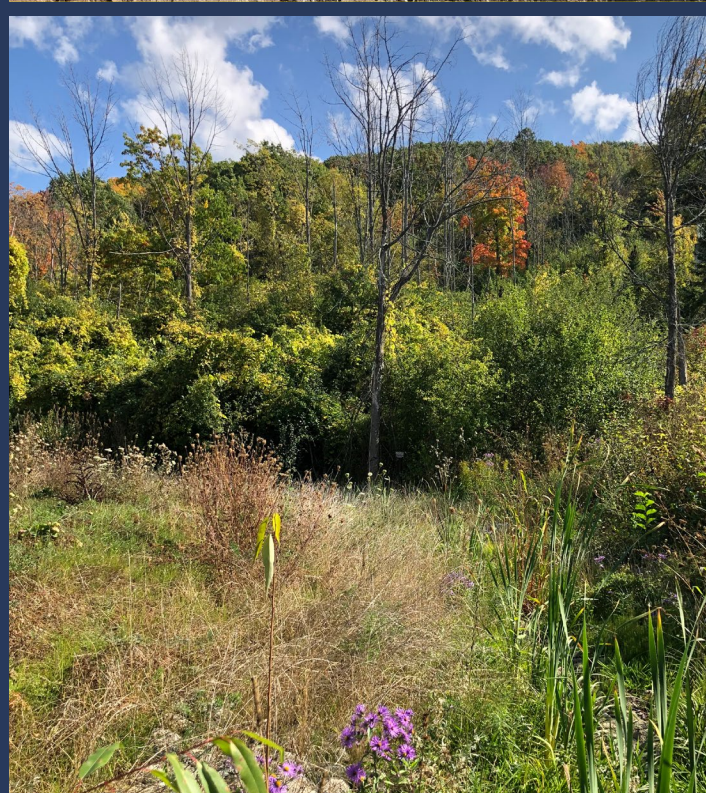
The interceptor swale was redesigned with a V-shaped cross-section. With an approximate grade of 2.6%, the swale was designed to handle 100 year SCS storm peak flow rate of 1.35 m<sup>3</sup>/s. This design capacity ensured the swale would withstand significant storm events without excessive erosion.

Flexamat Plus was selected for its durability and erosion capabilities. Flexamat Plus consists of interconnected concrete blocks, reinforced with bi-axial geogrid and underlaid with wood fibre (curlex) erosion control blanket, as well as a turf reinforcement mat made of polypropylene. The 38mm spacing between the blocks allows flexibility and accommodates vegetation growth, with roots reinforcing the mat. Flexamat Plus has been tested to ASTM D6460, achieving a shear resistance of 1,149 Pa and supporting a flow velocity of up to 5.8 m/s under unvegetated conditions.

The contractor ordered six 16' wide rolls of Flexamat Plus, all with customizable lengths, providing a total coverage of 230' in length. Installation was straight forward and efficient, taking just half a day with an excavator operator and four additional workers on the ground. The rolls were installed over seeding to support vegetative growth. This approach ensured that the swale would not only have immediate erosion control protection but would also promote long-term stabilization through root systems. Fill vegetation was established within a year, providing additional natural reinforcement against erosion.
