# Eglinton Crosstown LRT Maintenance Access Road

Product Installed: Ecoraster

System: Stormwater Management

CASE STUDY

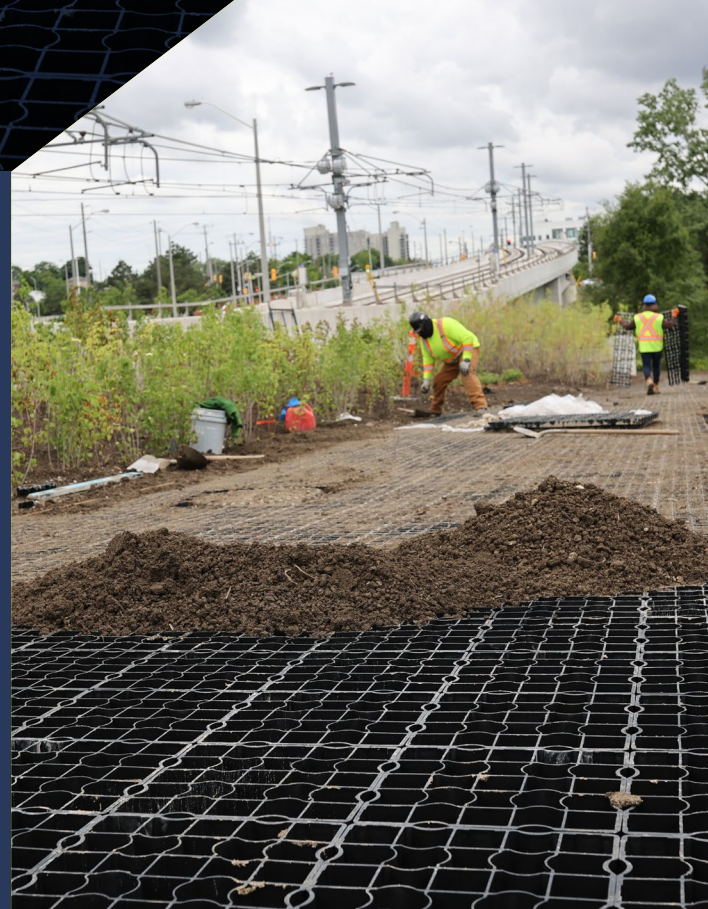
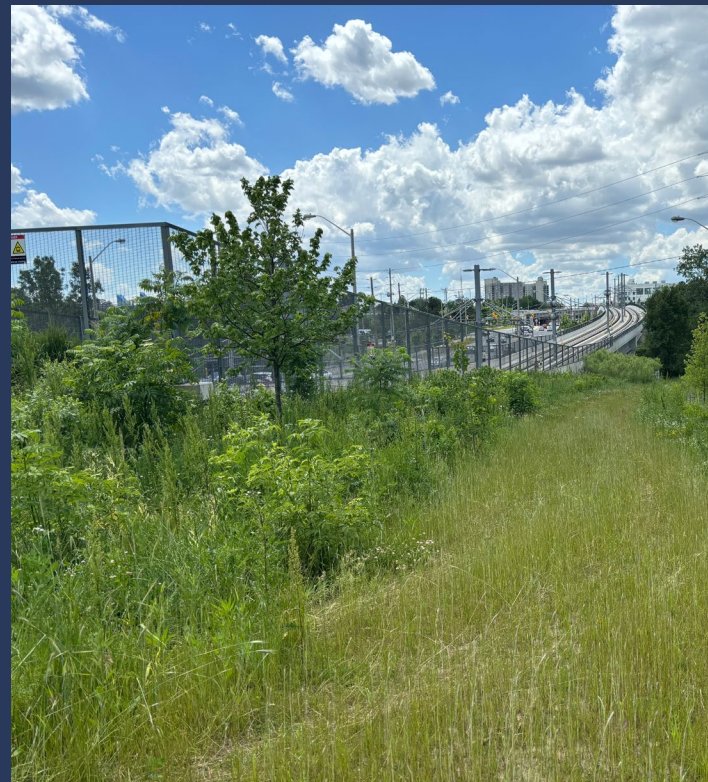
The installation process was simplified by the E50's modular design, making it straightforward to implement. The cells were filled with soil and seed. Ultimately, the entire feature resulted in a grass-like appearance with robust permeable reinforcement concealed beneath.
